To: Azadeh Safaie – City of Coquitlam **Date:** November 25, 2024

C: _____ **File:** 2400754

Subject: Geotechnical Comment: 560 Sydney Ave, Coquitlam – Demolition

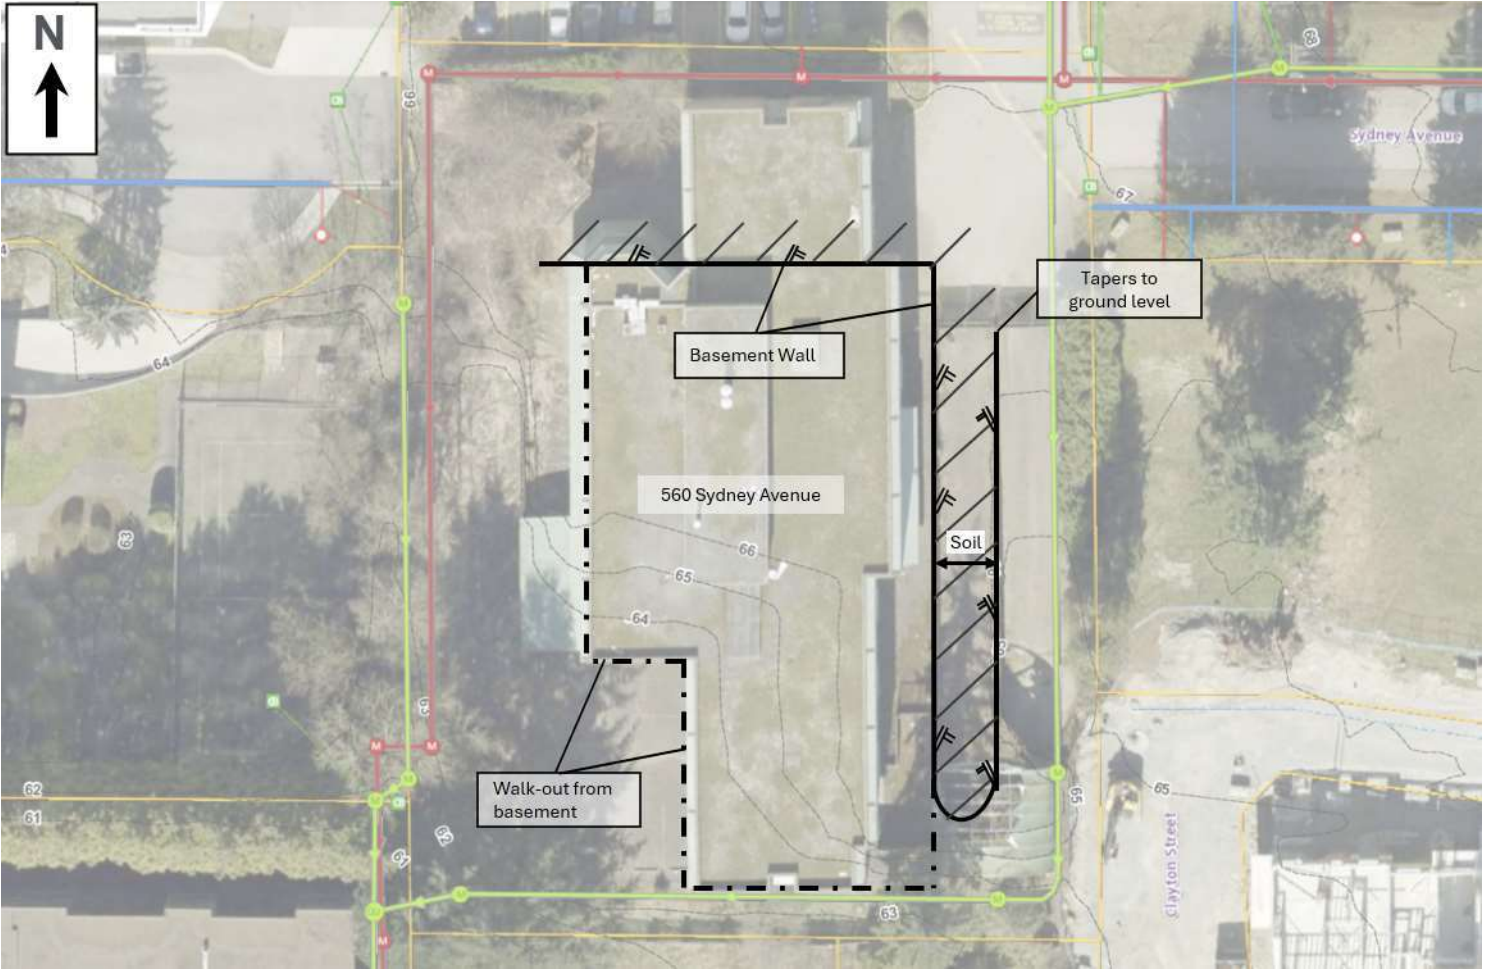
Figure 1.0

Ecora has reviewed the available drawings (attached in Appendix B) to confirm the extent of the basement structures. Figure 1 attached shows the general layout of the current structure and indicates the City’s utilities are on all four sides on the property.

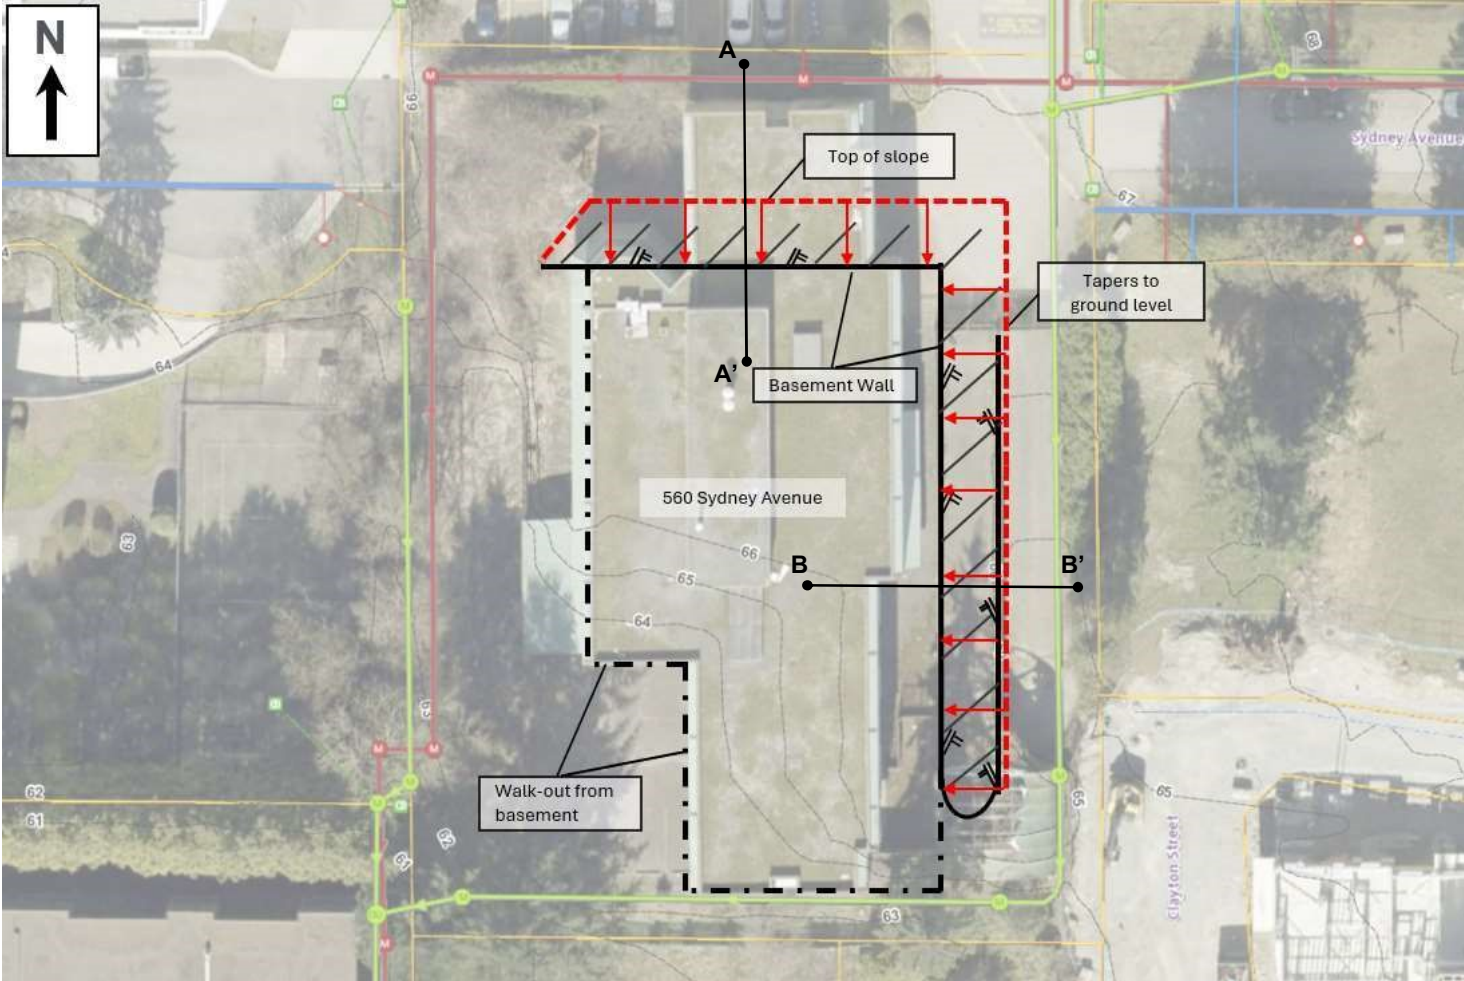
Figure 2.0

The bulk of the building demolition can be completed using temporary excavations which do not extend off the property. The schematic (see Figures 2 & 3 attached) shows the approximate extent of excavation required to remove the basement level structure including foundations. While the depth of foundations is not known, based on the significant setback of basement walls from property lines, it is reasonable to conclude that the temporary excavation slopes required to remove the basement structure will not encroach onto or impact existing City of Coquitlam utilities to the north, south, east and west of the property.

Locally, excavation to remove foundations close to existing utilities on the north, east and south of the site may extend close to the utilities. Given that foundation drawings for the existing building are not available, test excavation in the presence of the geotechnical engineer and/or the City representative at the time of demolition should be undertaken to confirm the relationship of foundations to utilities, and to finalize excavation/demolition plans.

Following demolition and removal of all foundations, utilities and other improvements as per the City of Coquitlam's requirements, the site should be graded so that the permanent slopes tie back to the access ramp level on the east side of the site and graded to a 2H:1V slope or flatter along the north side of the site.

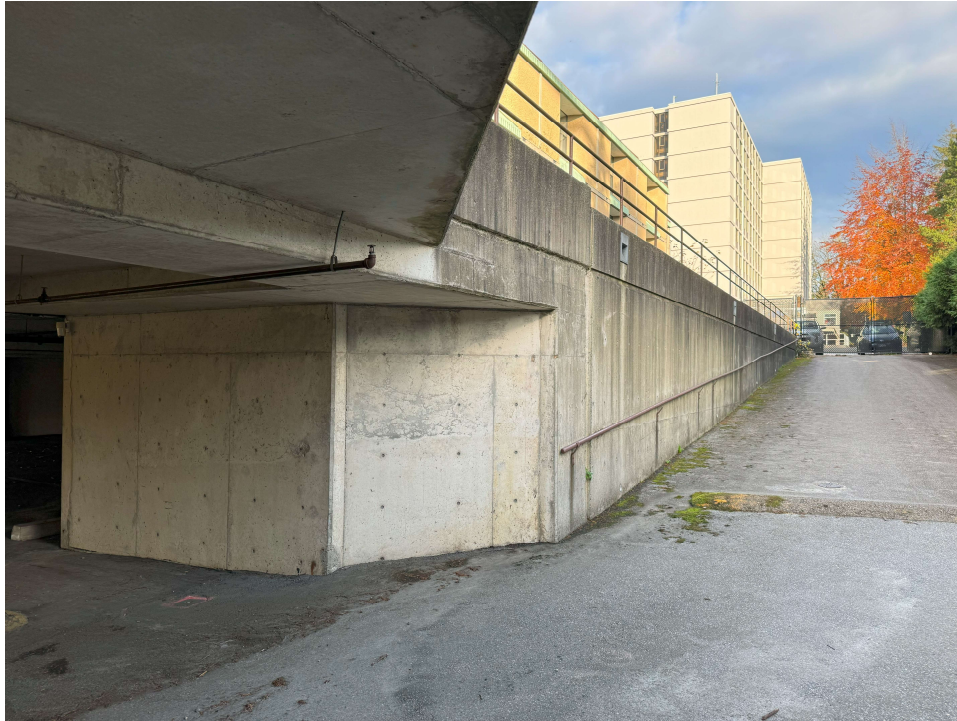
Photo 1 View north, access ramp from Sydney Ave down into basement car park.

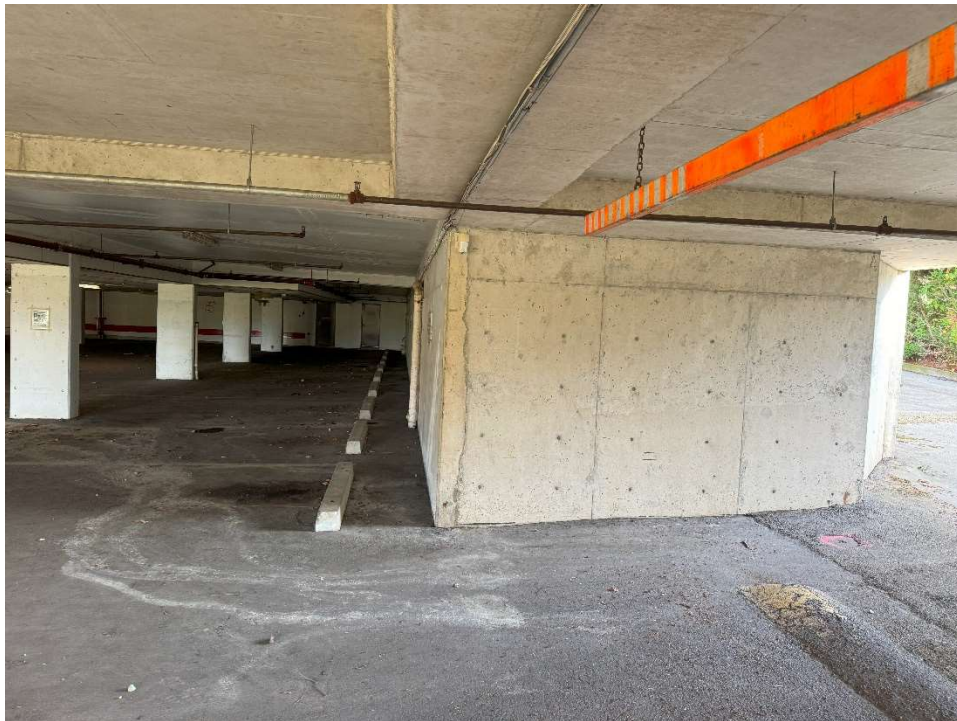
- The basement walls are approximately 3 m in height. The northern wall extends about 30 m from east to west, while the eastern wall measures approximately 40 m from north to south.
- A third retaining wall runs parallel to the western basement wall and the access ramp. This wall tapers at the northeast corner of the site, where the access ramp begins.
- A “wing wall” retains the slope to the west of the building along the north side of the basement grade exterior parking.

Photo 2 View north, showing basement walls.

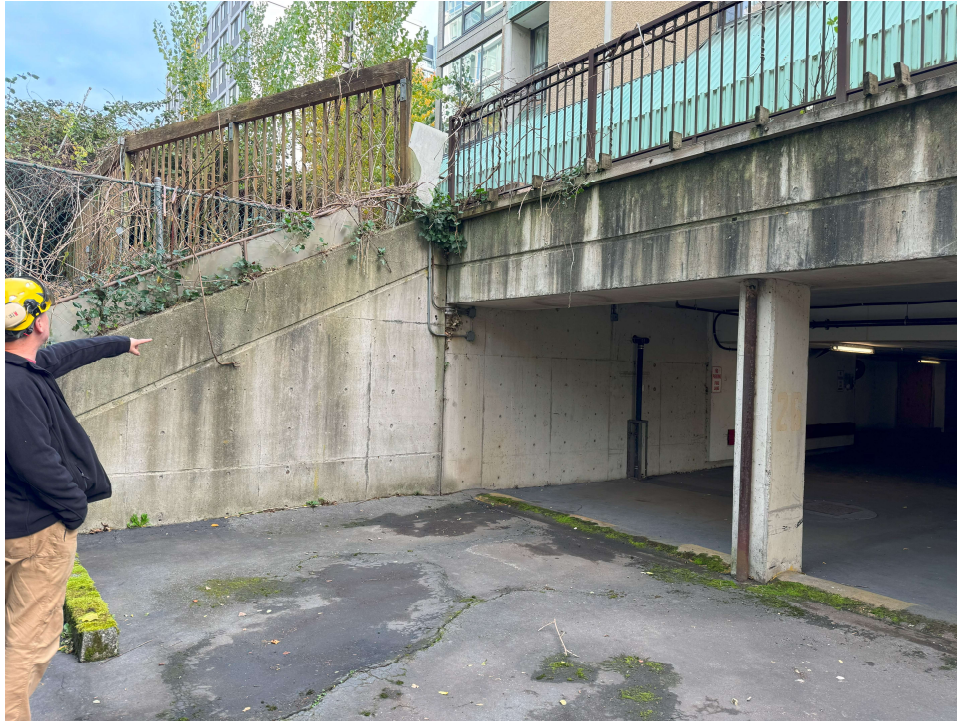
Photo 3 View north, showing northern “wing wall”.

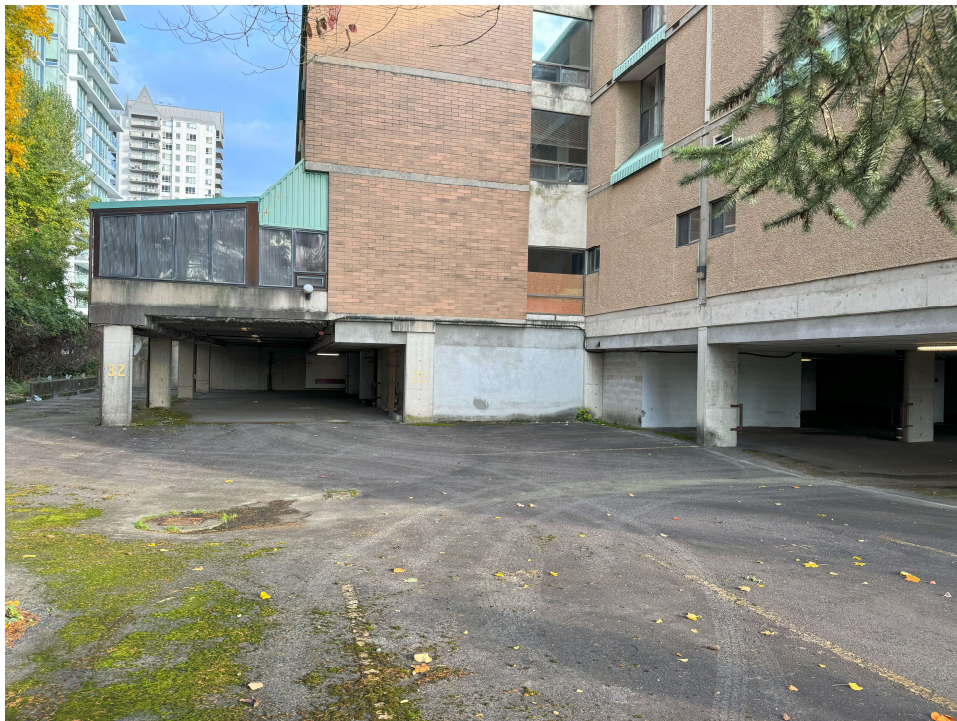
Photo 4 View north, showing walk out to ground level at the southern and western side of property.

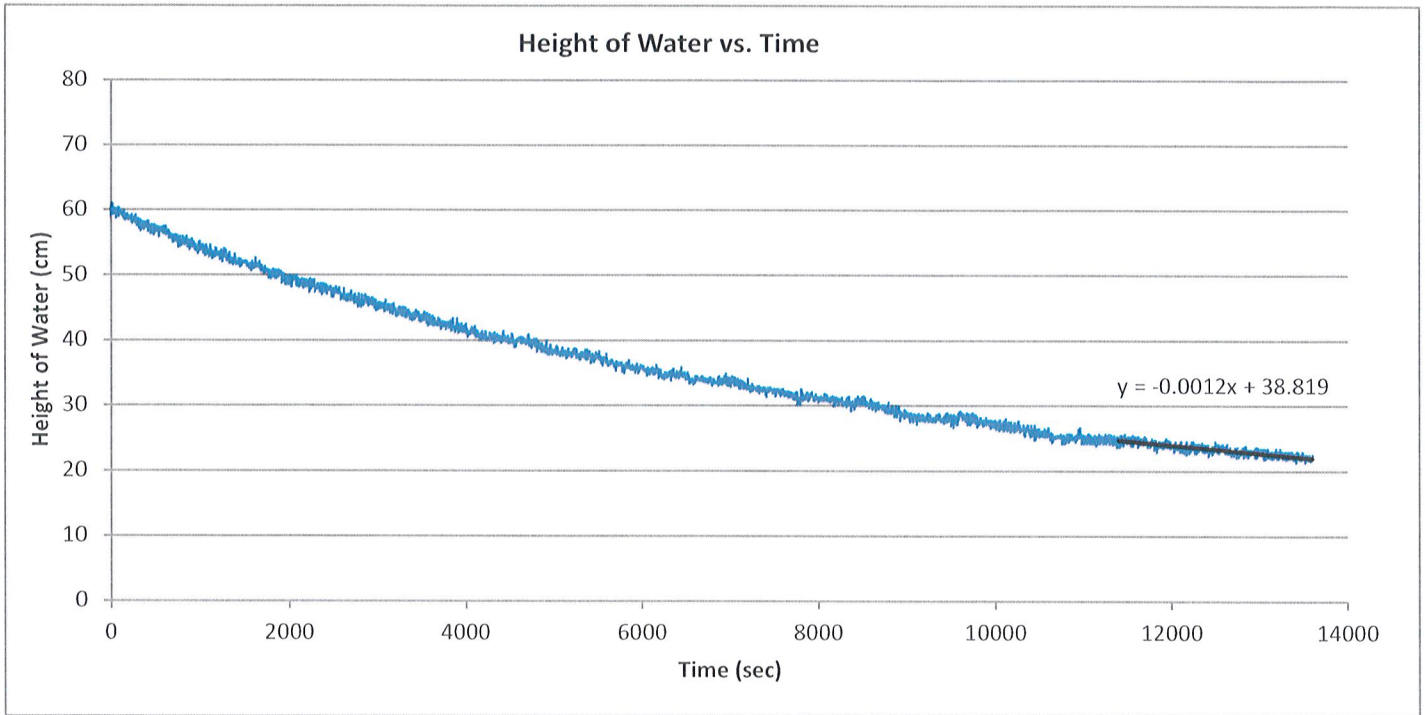
CLIENT:	VANMAR CONSTRUCTORS 1114 INC.	PROJECT #:	23650
PROJECT NAME:	PROPOSED SENIORS RENTAL HOUSING DEVELOPMENT	DATE:	01-Mar-2024 8:45
PROJECT LOCATION:	594 - 602 SYDNEY AVENUE, COQUITLAM, BC	TEST NO.:	DRIT24-01

ESTIMATED FIELD SATURATED INFILTRATION RATE:	44.6	mm/Hr
---	-------------	--------------

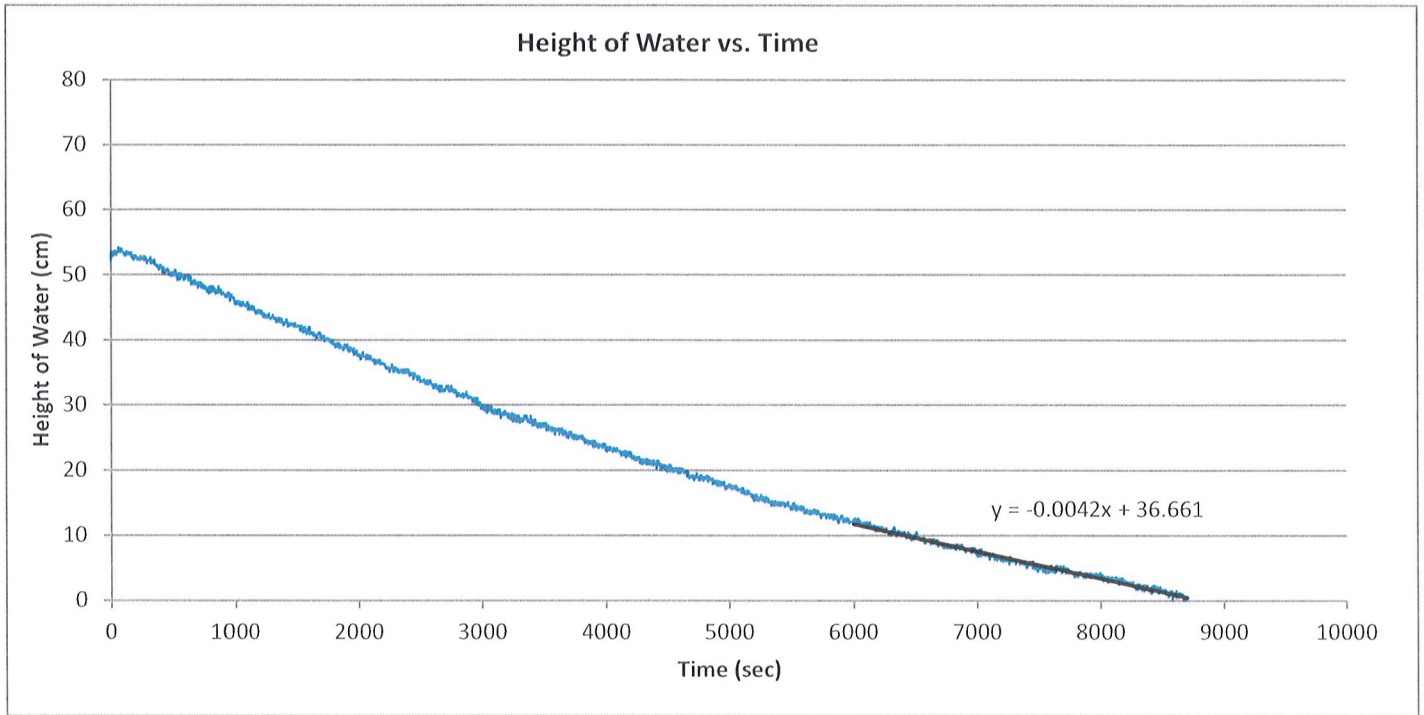
CLIENT:	VANMAR CONSTRUCTORS 1114 INC.	PROJECT #:	23650
PROJECT NAME:	PROPOSED SENIORS RENTAL HOUSING DEVELOPMENT	DATE:	01-Mar-2024 9:30
PROJECT LOCATION:	594 - 602 SYDNEY AVENUE, COQUITLAM, BC	TEST NO.:	DRIT24-02

ESTIMATED FIELD SATURATED INFILTRATION RATE:	149.8	mm/Hr
---	--------------	--------------
