Re: LIMITED INSPECTION AND RISK ASSESSMENT FOR BUILDING MATERIALS POTENTIALLY CONTAINING ASBESTOS, LEAD, AND OTHER HAZARDOUS MATERIALS

Site Location: 640 POIRIER STREET, COQUITLAM, BRITISH COLUMBIA

Work Order: 25-00505-E

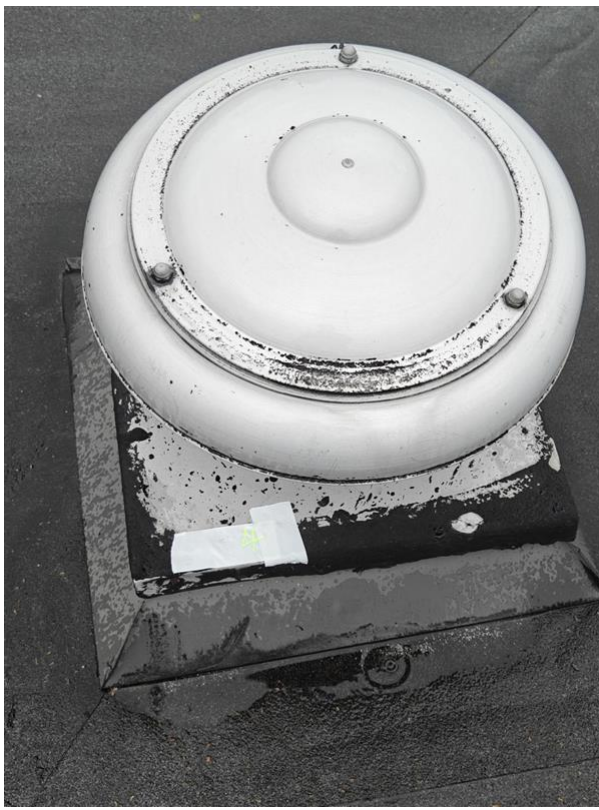
Material Type:	Mastic

Substrate:	Metal		
Sample Number(s):	04		
Location(s):	Exterior – Roof - Big Vent Mastic		
Condition:	Good	Current Exposure Risk:	Low
Accessibility:	High	Approx. Quantity:	Around 2 Big Vents
Friability:	No	Risk Assessment for Abatement:	“Moderate Risk”

The material was observed to be in good condition and does not pose an immediate health or exposure risk to individuals if the material is left undisturbed.

WorkSafeBC “Moderate Risk” asbestos work procedures will be required to remove the **Mastic** as outlined in the Safe Work Practices for Handling Asbestos guidelines, 2023 Publication.
