City of Coquitlam

Qualitative Partial Risk Slope Analysis, Chines Escarpment and Corona Crescent Areas

June 2013

Re: Final Report: Qualitative Partial Risk Slope Analysis, Chines Escarpment and Corona Crescent Areas

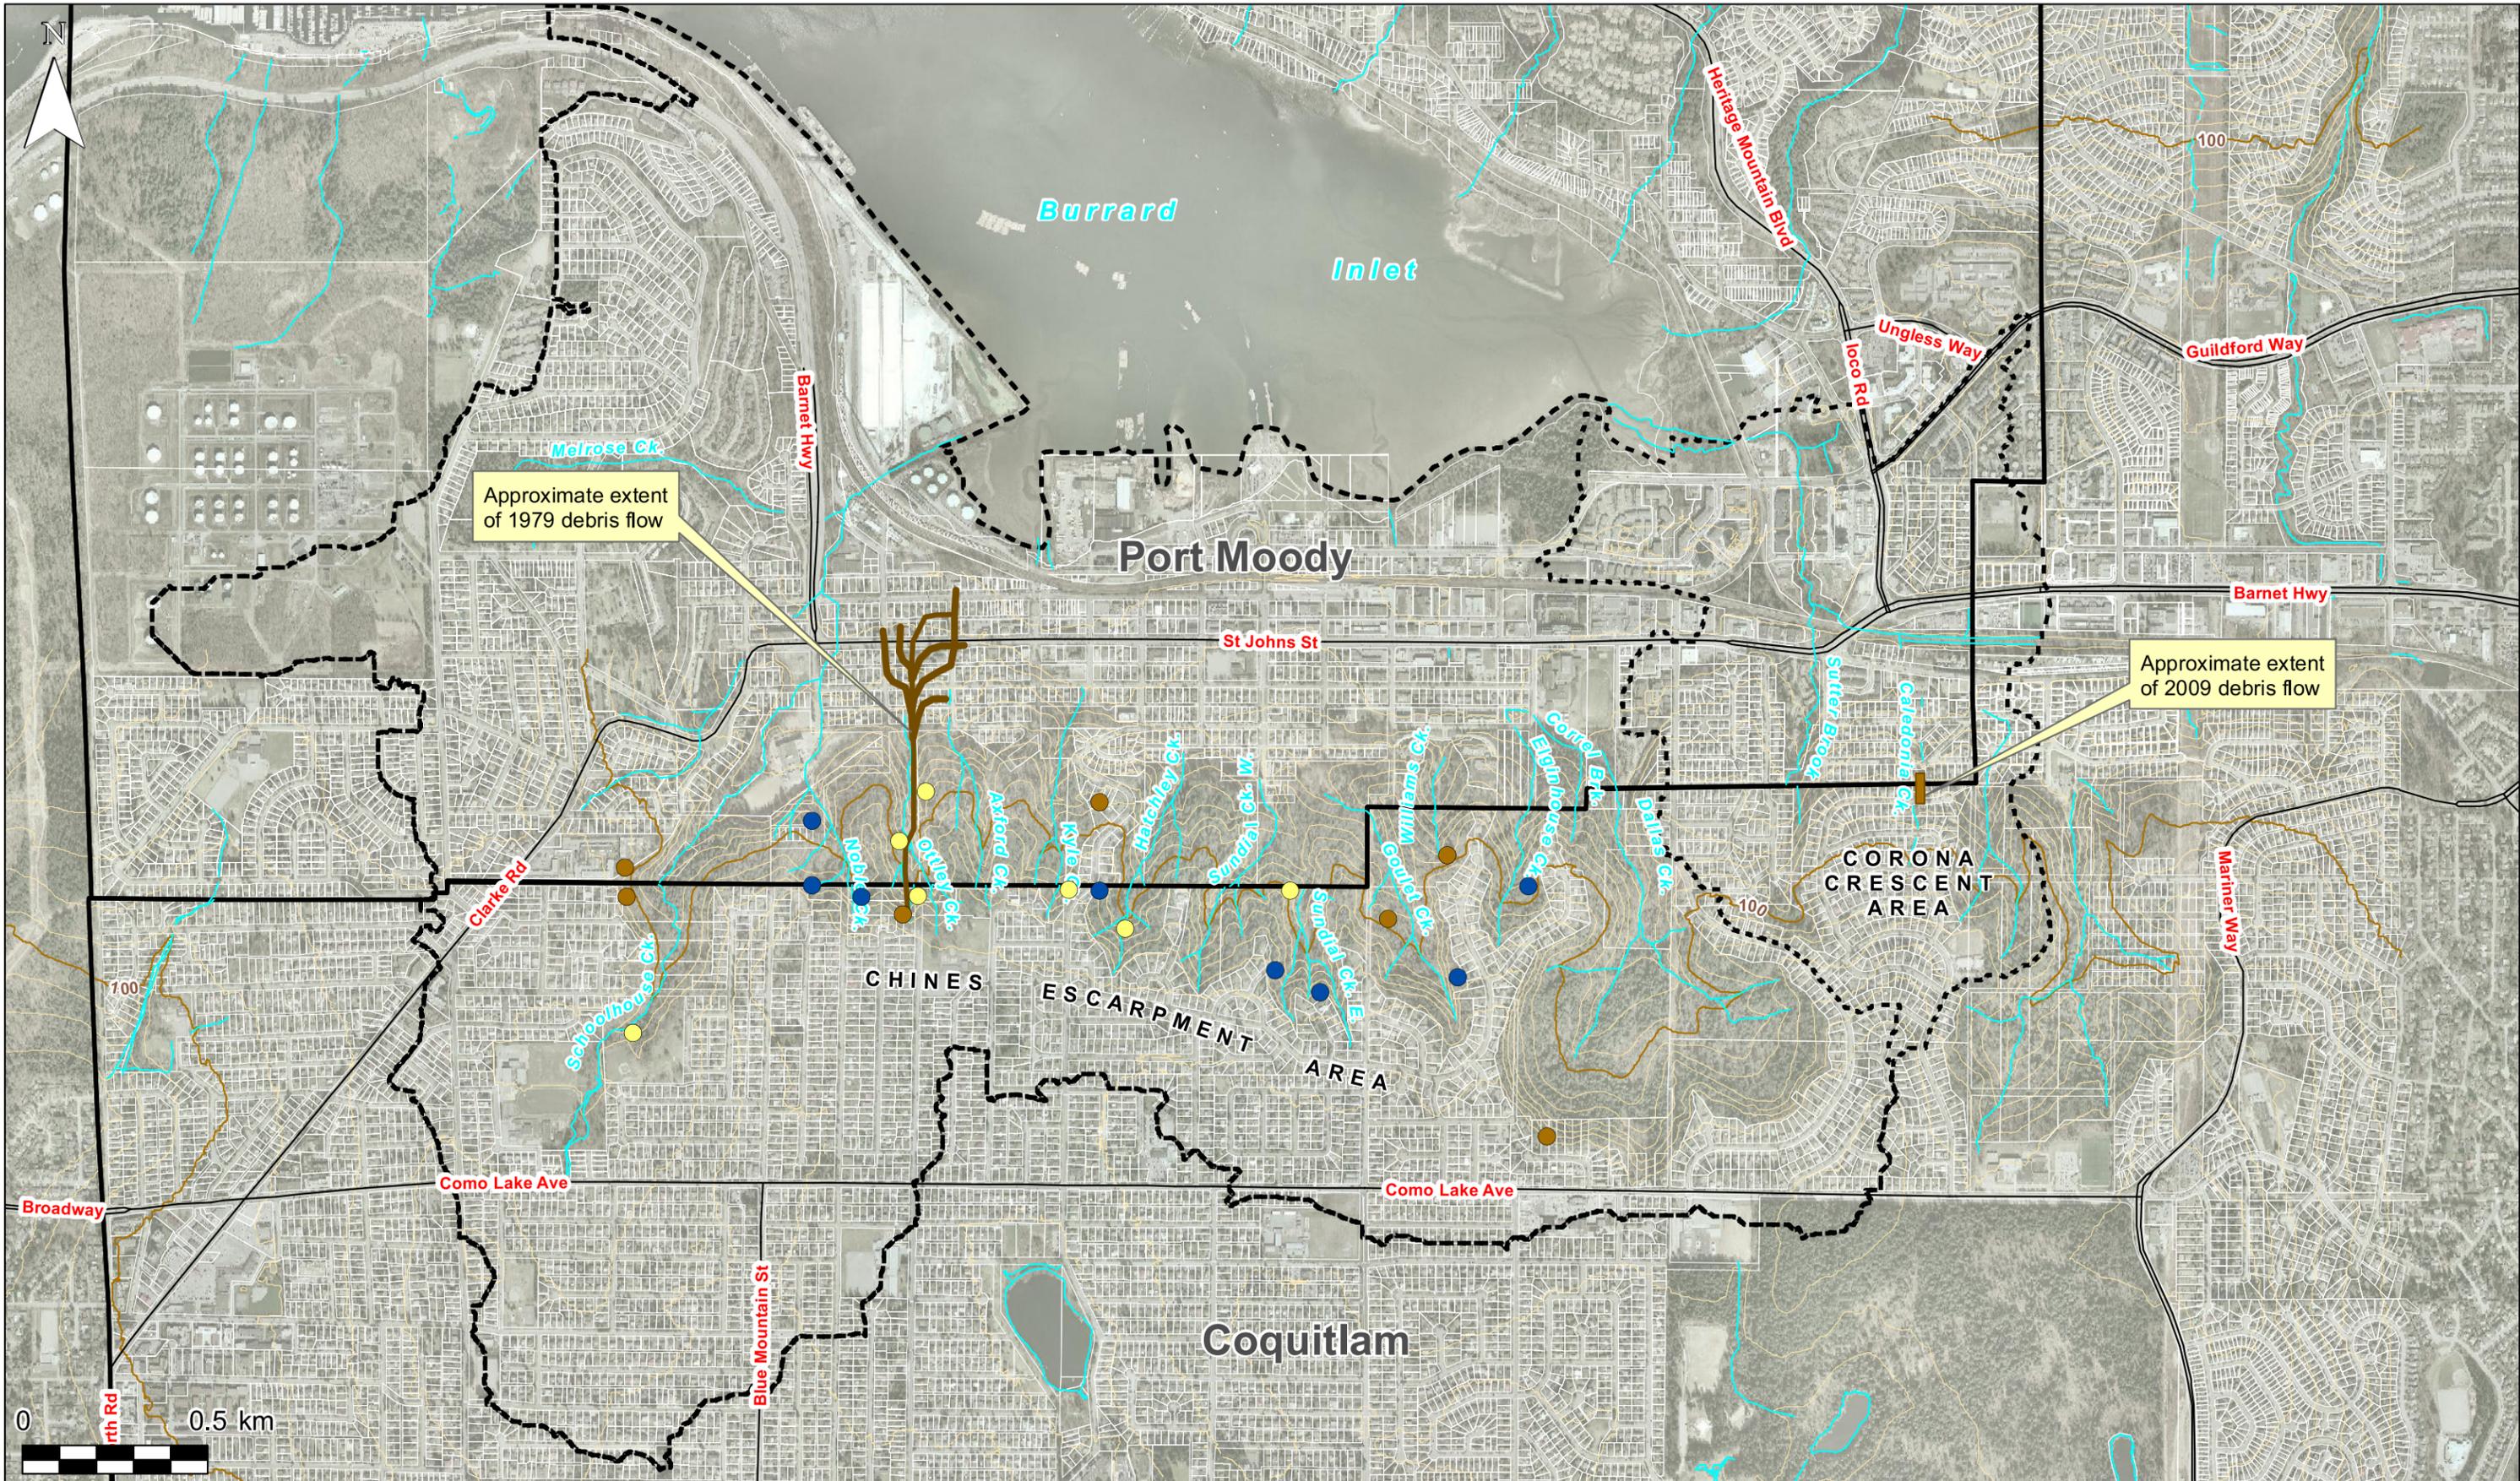
PORT MOODY COQUITLAM DRAINAGE AREA ISMP
Figure 1-1: Project Area and Landslide and Erosion Events

The debris flow damaged several residences, structures and vehicles, and put lives in danger (Figure 1-1; Eisbacher and Clague (1981); Thurber (1988)). This debris flow nearly caused serious injury to four people - a house with three residents was impacted by the debris and knocked off its foundation, and a basement apartment with one resident was rapidly inundated. The people managed to escape the affected houses, and no serious injuries occurred (Eisbacher and Clague (1981); Thurber (1988); Evans and Savigny (1994)).

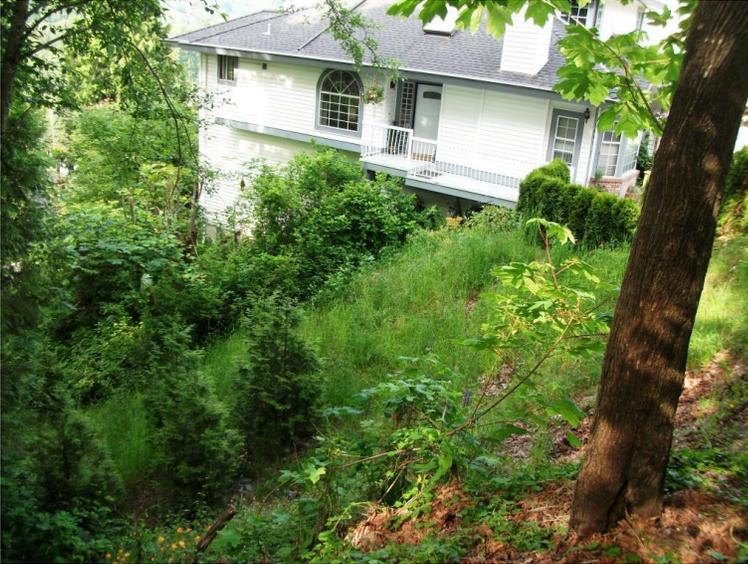
Photo 1: View across headscarp area, now rehabilitated with grass and shrubs.

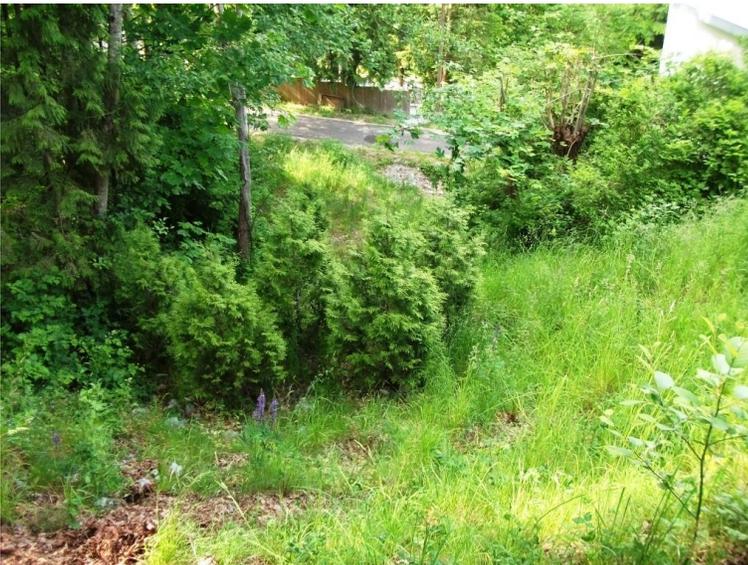
Photo 2: View down track of debris flow, now rehabilitated with grass, shrubs and small trees.

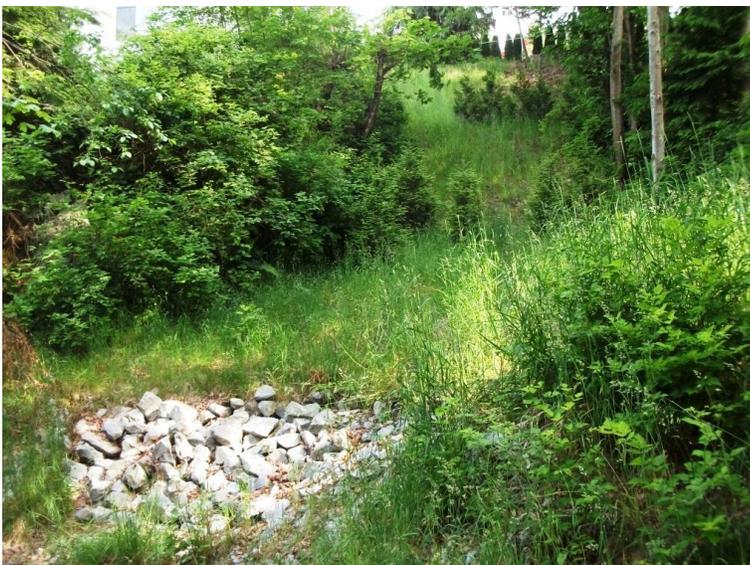
Photo 3: View up debris flow track with rock fill at culvert inlet.

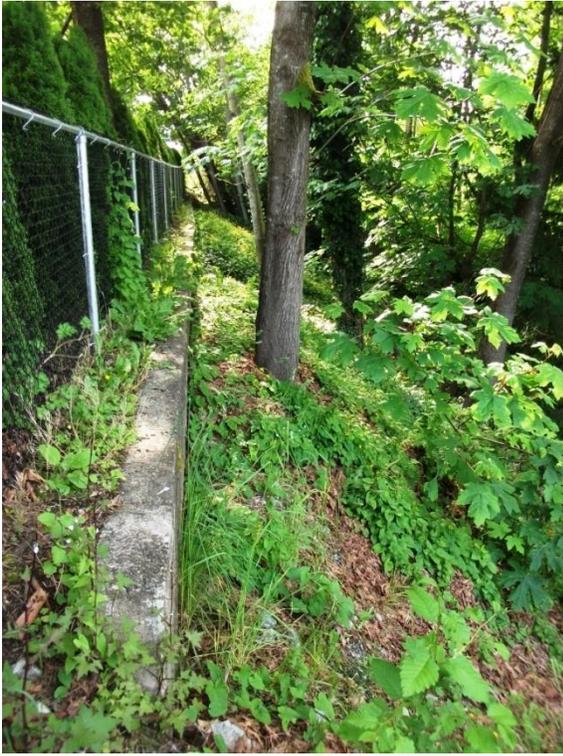
Photo 4: View along City concrete retaining wall above debris flow headscarp and below Corona Crescent. The wall is generally straight.

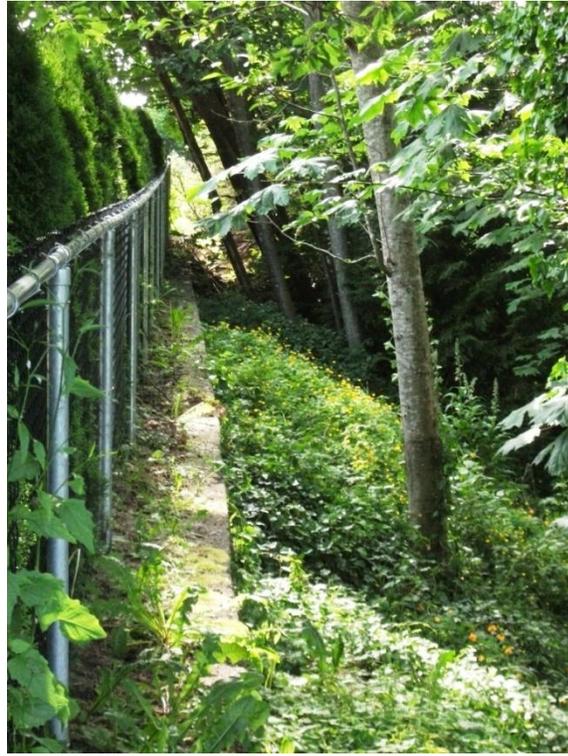
Photo 5: View along City concrete retaining wall with outward bulge, west along Corona Crescent from headscarp area. Small deciduous trees have tipped from shifted surface soils.

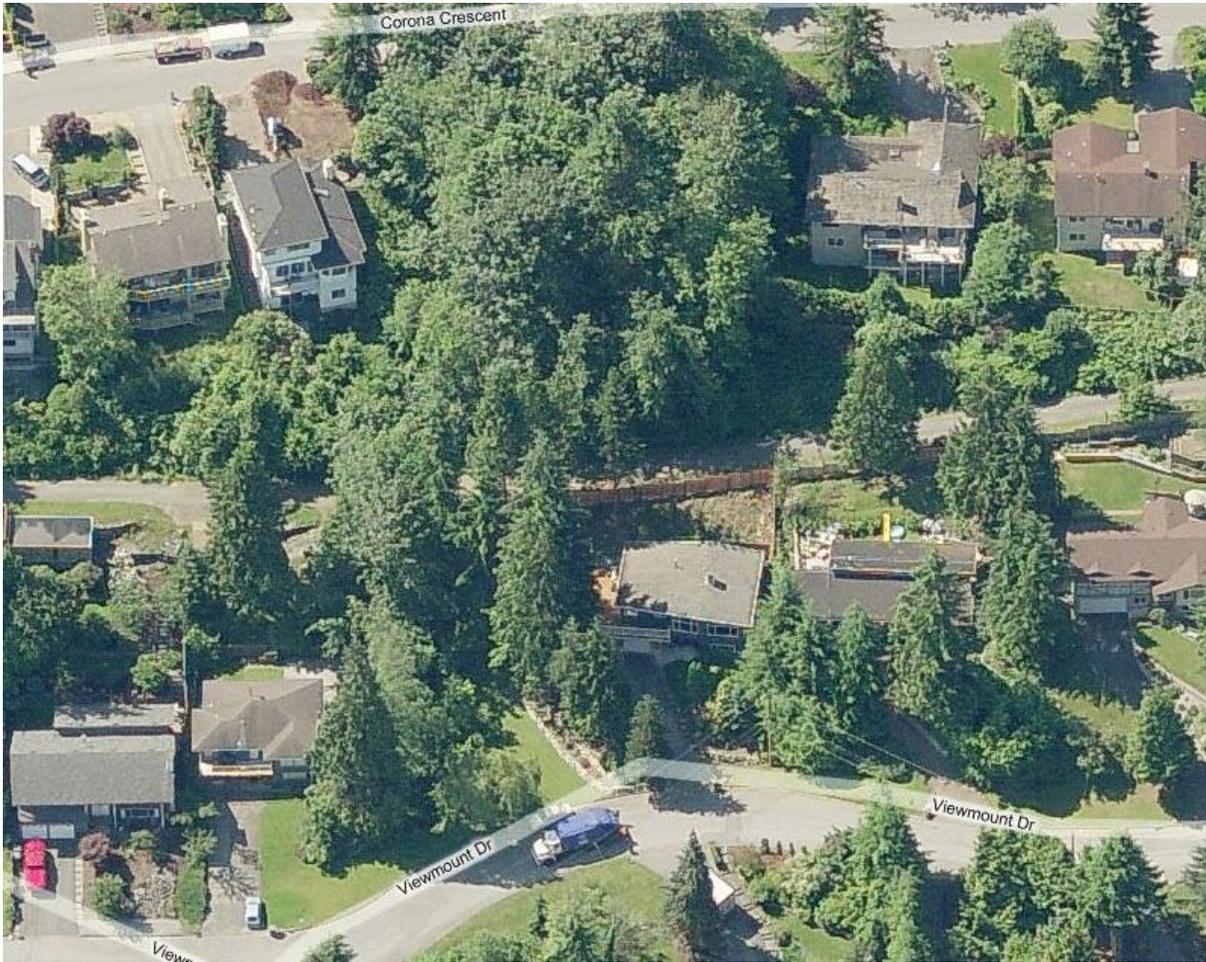
Photo 6: View over future debris flow track, pre 2009. The future headscarp is about at top centre. Some deciduous and evergreen trees were removed by the failure, with most depositing on a paved lane in the centre of photo. Photo from Bing Maps.

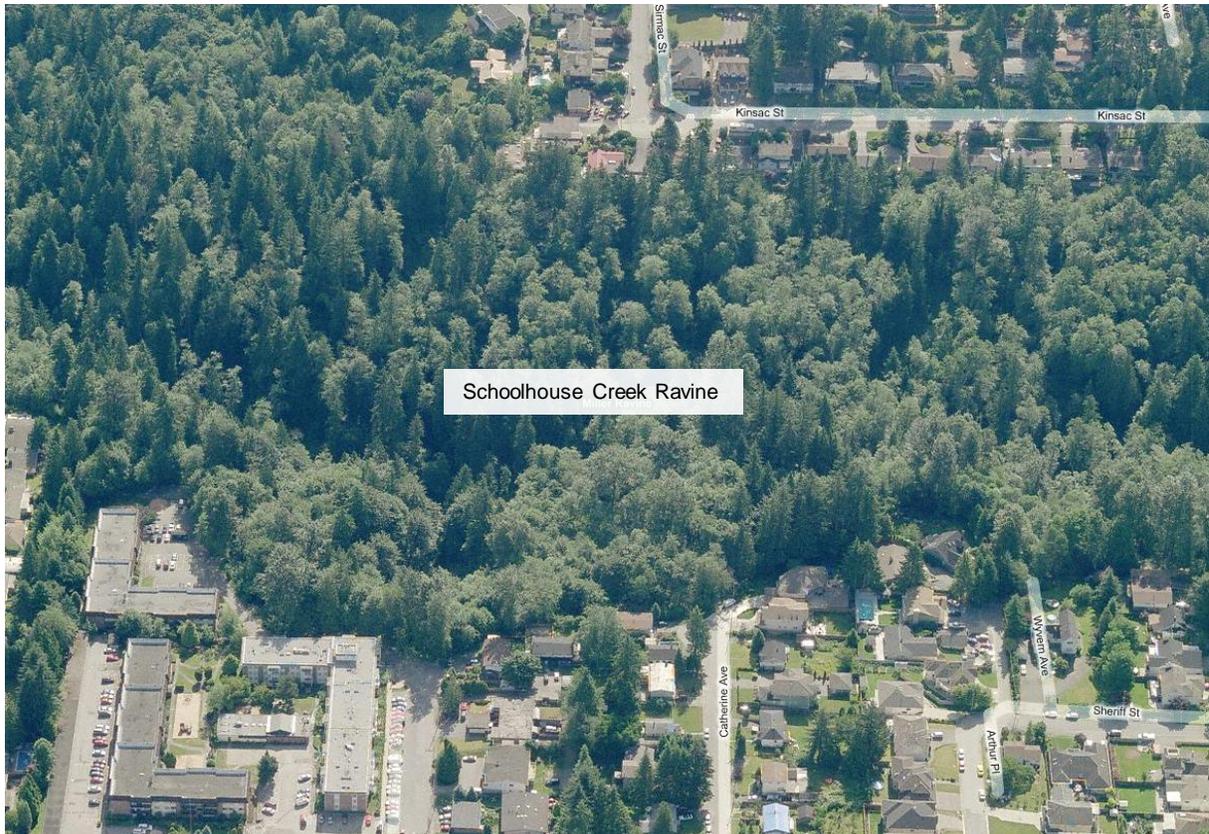
Photo 7: View of middle section of Schoolhouse Creek ravine, with 902 Ingersoll apartment building at lower left, houses at end of Catherine Street in lower centre, and property with large fill off Wyvem in lower right. Photo from Bing Maps.

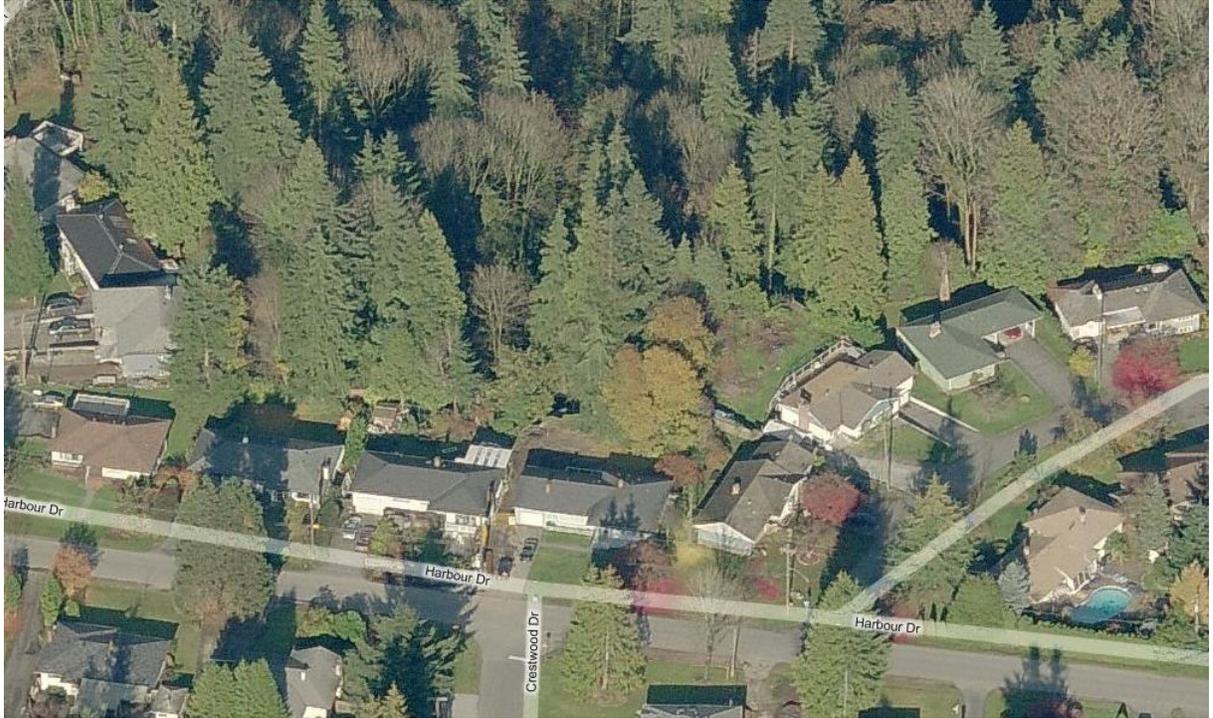
Photo 8: View north to house at 1445 Harbour Drive (corner of Harbour and Crestwood) where a City stormwater pipe flows into the ravine on an armoured track, below a concrete retaining wall with some subsidence indicators. Photo from Bing Maps.

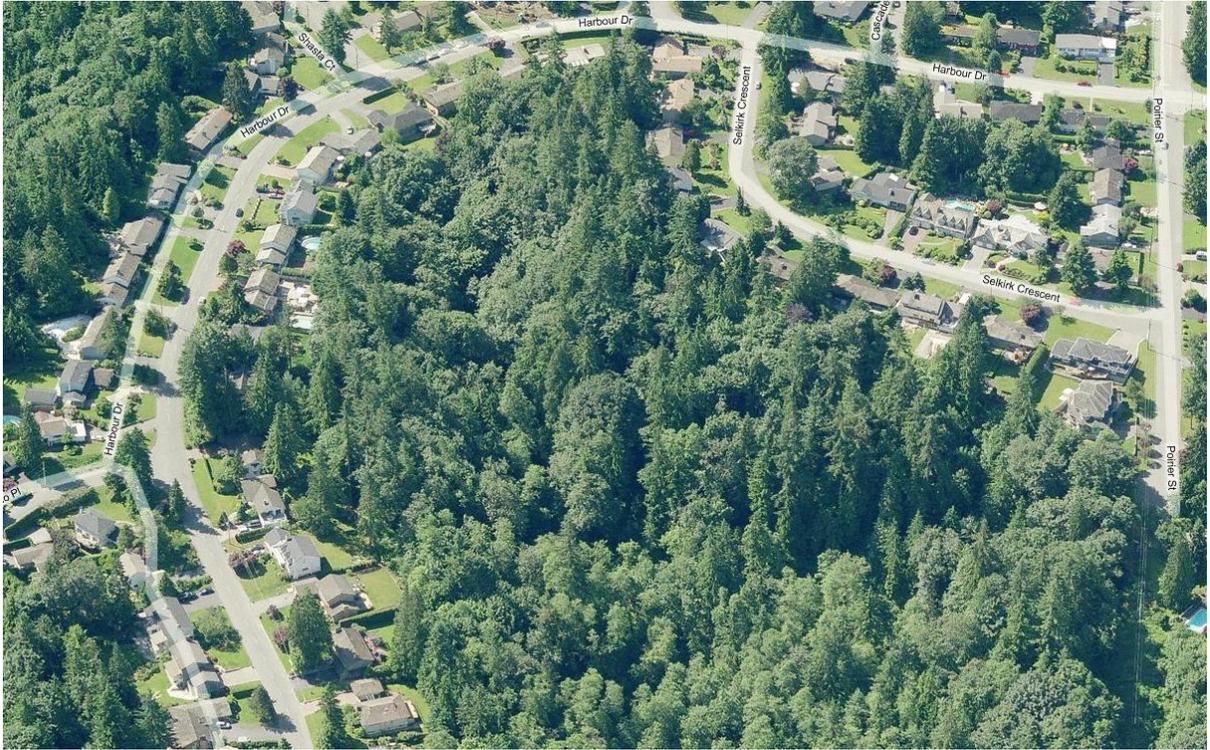
Photo 9: View south over Harbour Drive area, with steep natural slopes below houses left of centre, and below Selkirk Crescent and Porter Streets. Photo from Bing Maps.

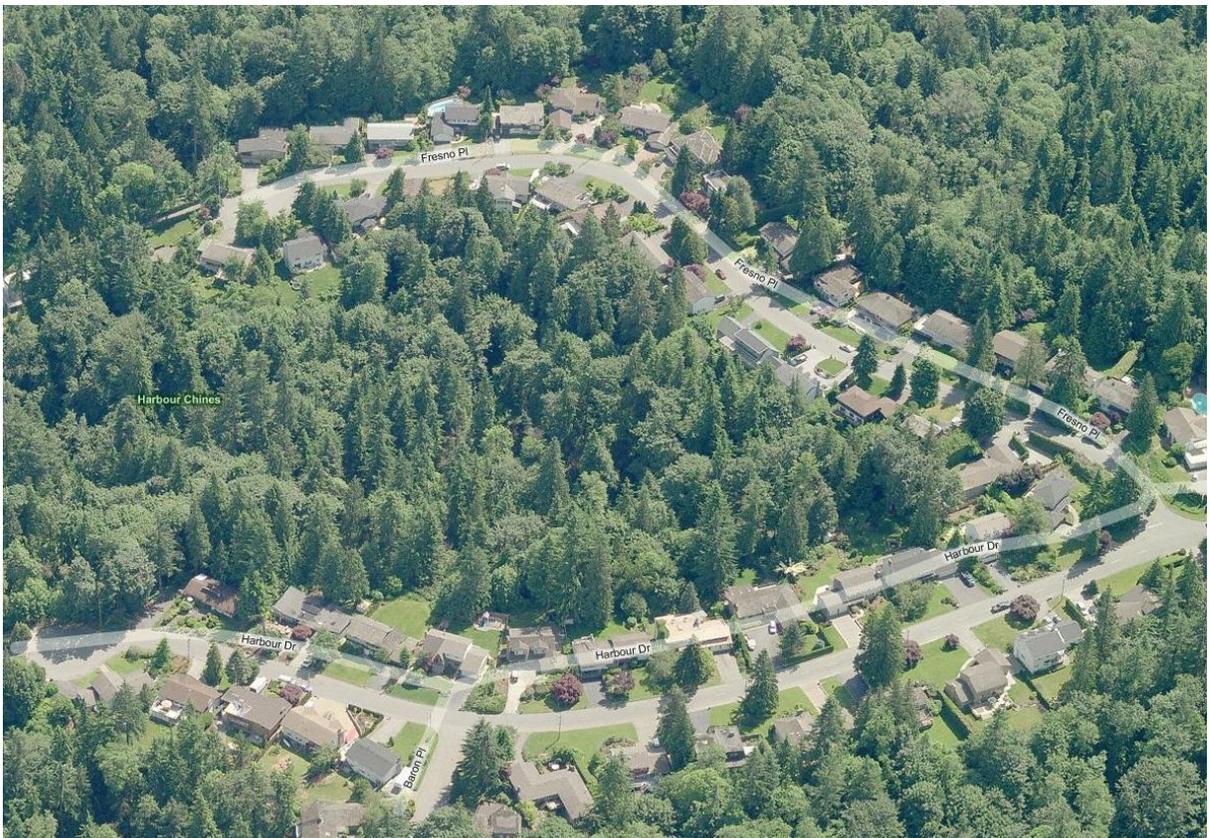
Photo 10: View east over north ends of Harbour Drive and Fresno Place, with natural steep slopes below houses. Photo from Bing Maps.

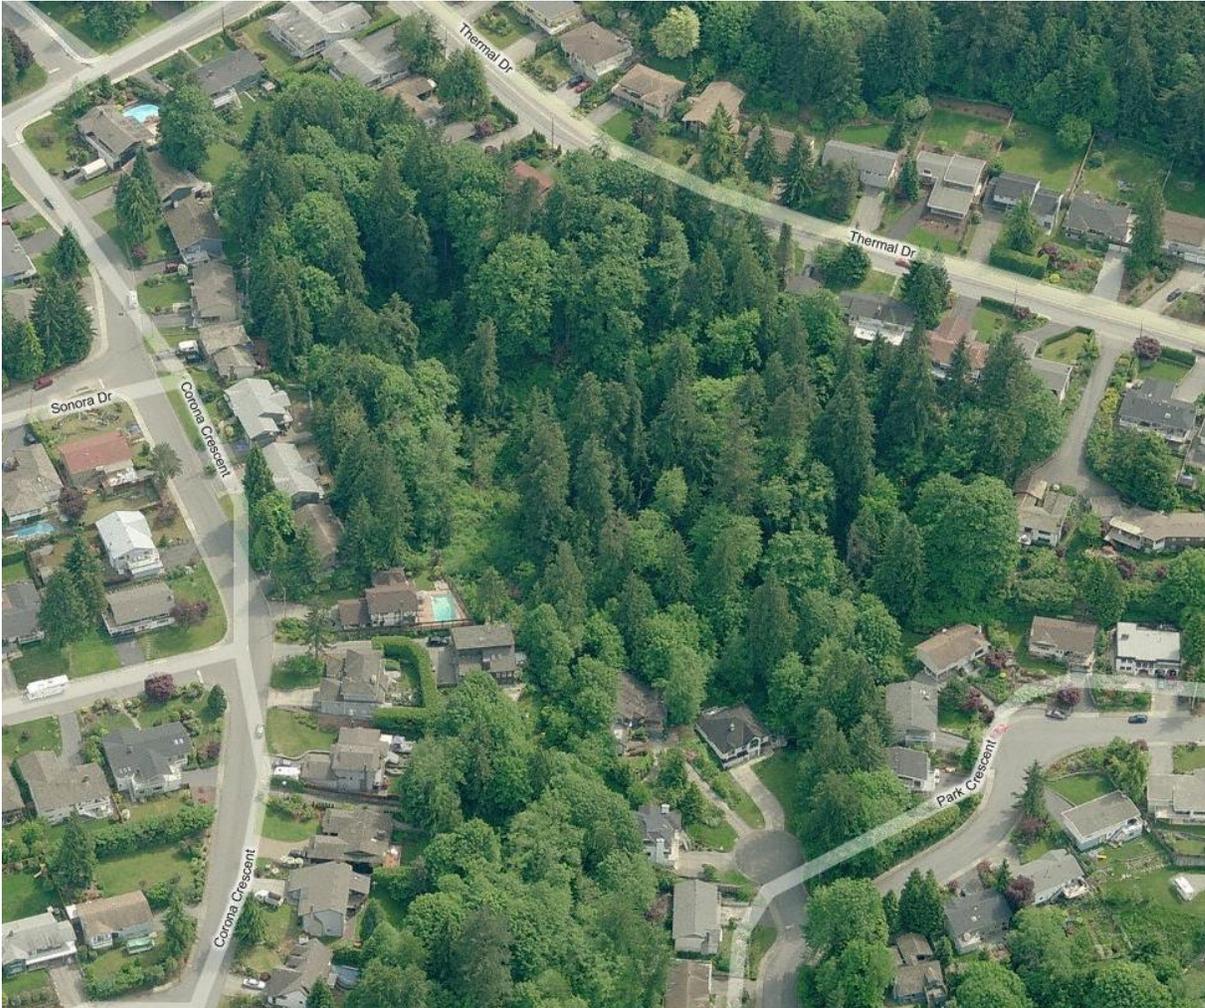
Photo 11: View south over Corona Crescent area, showing natural steep slopes below Corona Crescent and Thermal Drive, above houses on Park Crescent. Photo from Bing Maps.
