Technical Memorandum

RE: **CITY OF COQUITLAM – AUSTIN HEIGHTS FIRE HALL FAÇADE REPAIRS**
Wildlife Assessment
Our File 0456.152-300

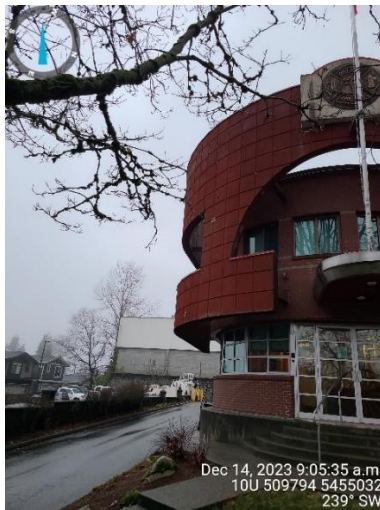
No active use of the façade by wildlife was documented during the site visit (Photo 1). Very limited bird activity was observed during the site visit; this is likely due to the time of year and poor weather conditions. No whitewash or guano was observed on the ground under the façade, however, whitewash (appeared to be dried) was observed on the façade immediately below multiple cavities (Photo 2, Photo 3). This likely indicates use by birds during the nesting season. Many cavities were adjacent to previous repairs (Photo 4).

Photo 1: Austin Heights Fire Hall Facade

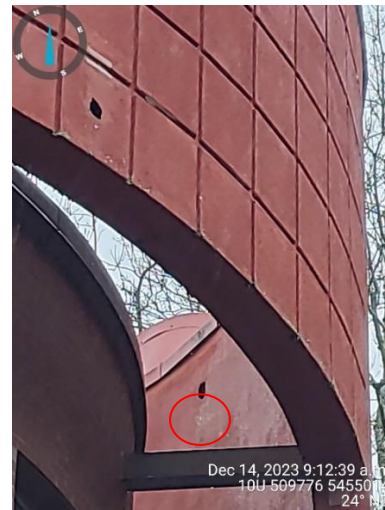
Photo 2: Bird Damage on Both Sides of Facade

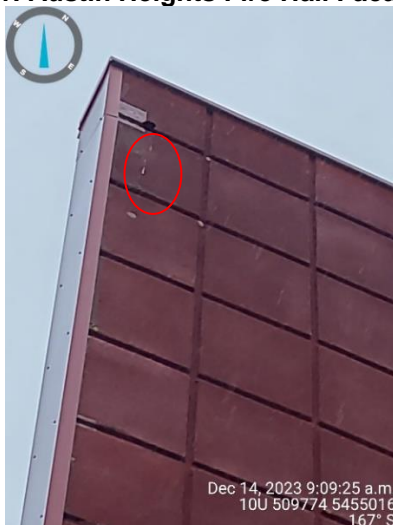
Photo 3: Whitewash Directly Below Cavity

- Façade repairs should be completed outside of the general nesting window for the area (March 1 to August 31). If works cannot be completed before the commencement of the nesting window, bird nest surveys should be undertaken by a QEP prior to start of works. If active nests or nesting activity is detected in and around the facade, works should be deferred until the QEP has confirmed the nests are fledged.

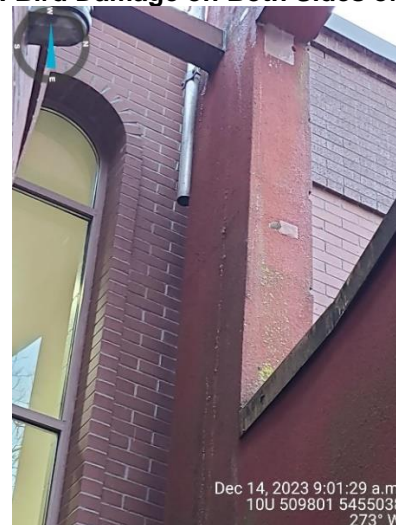
Photo 4: Cavities Adjacent to Previous Repairs
