City of Coquitlam

Qualitative Partial Risk Slope Analysis, Chines Escarpment and Corona Crescent Areas

June 2013

Re: Final Report: Qualitative Partial Risk Slope Analysis, Chines Escarpment and Corona Crescent Areas

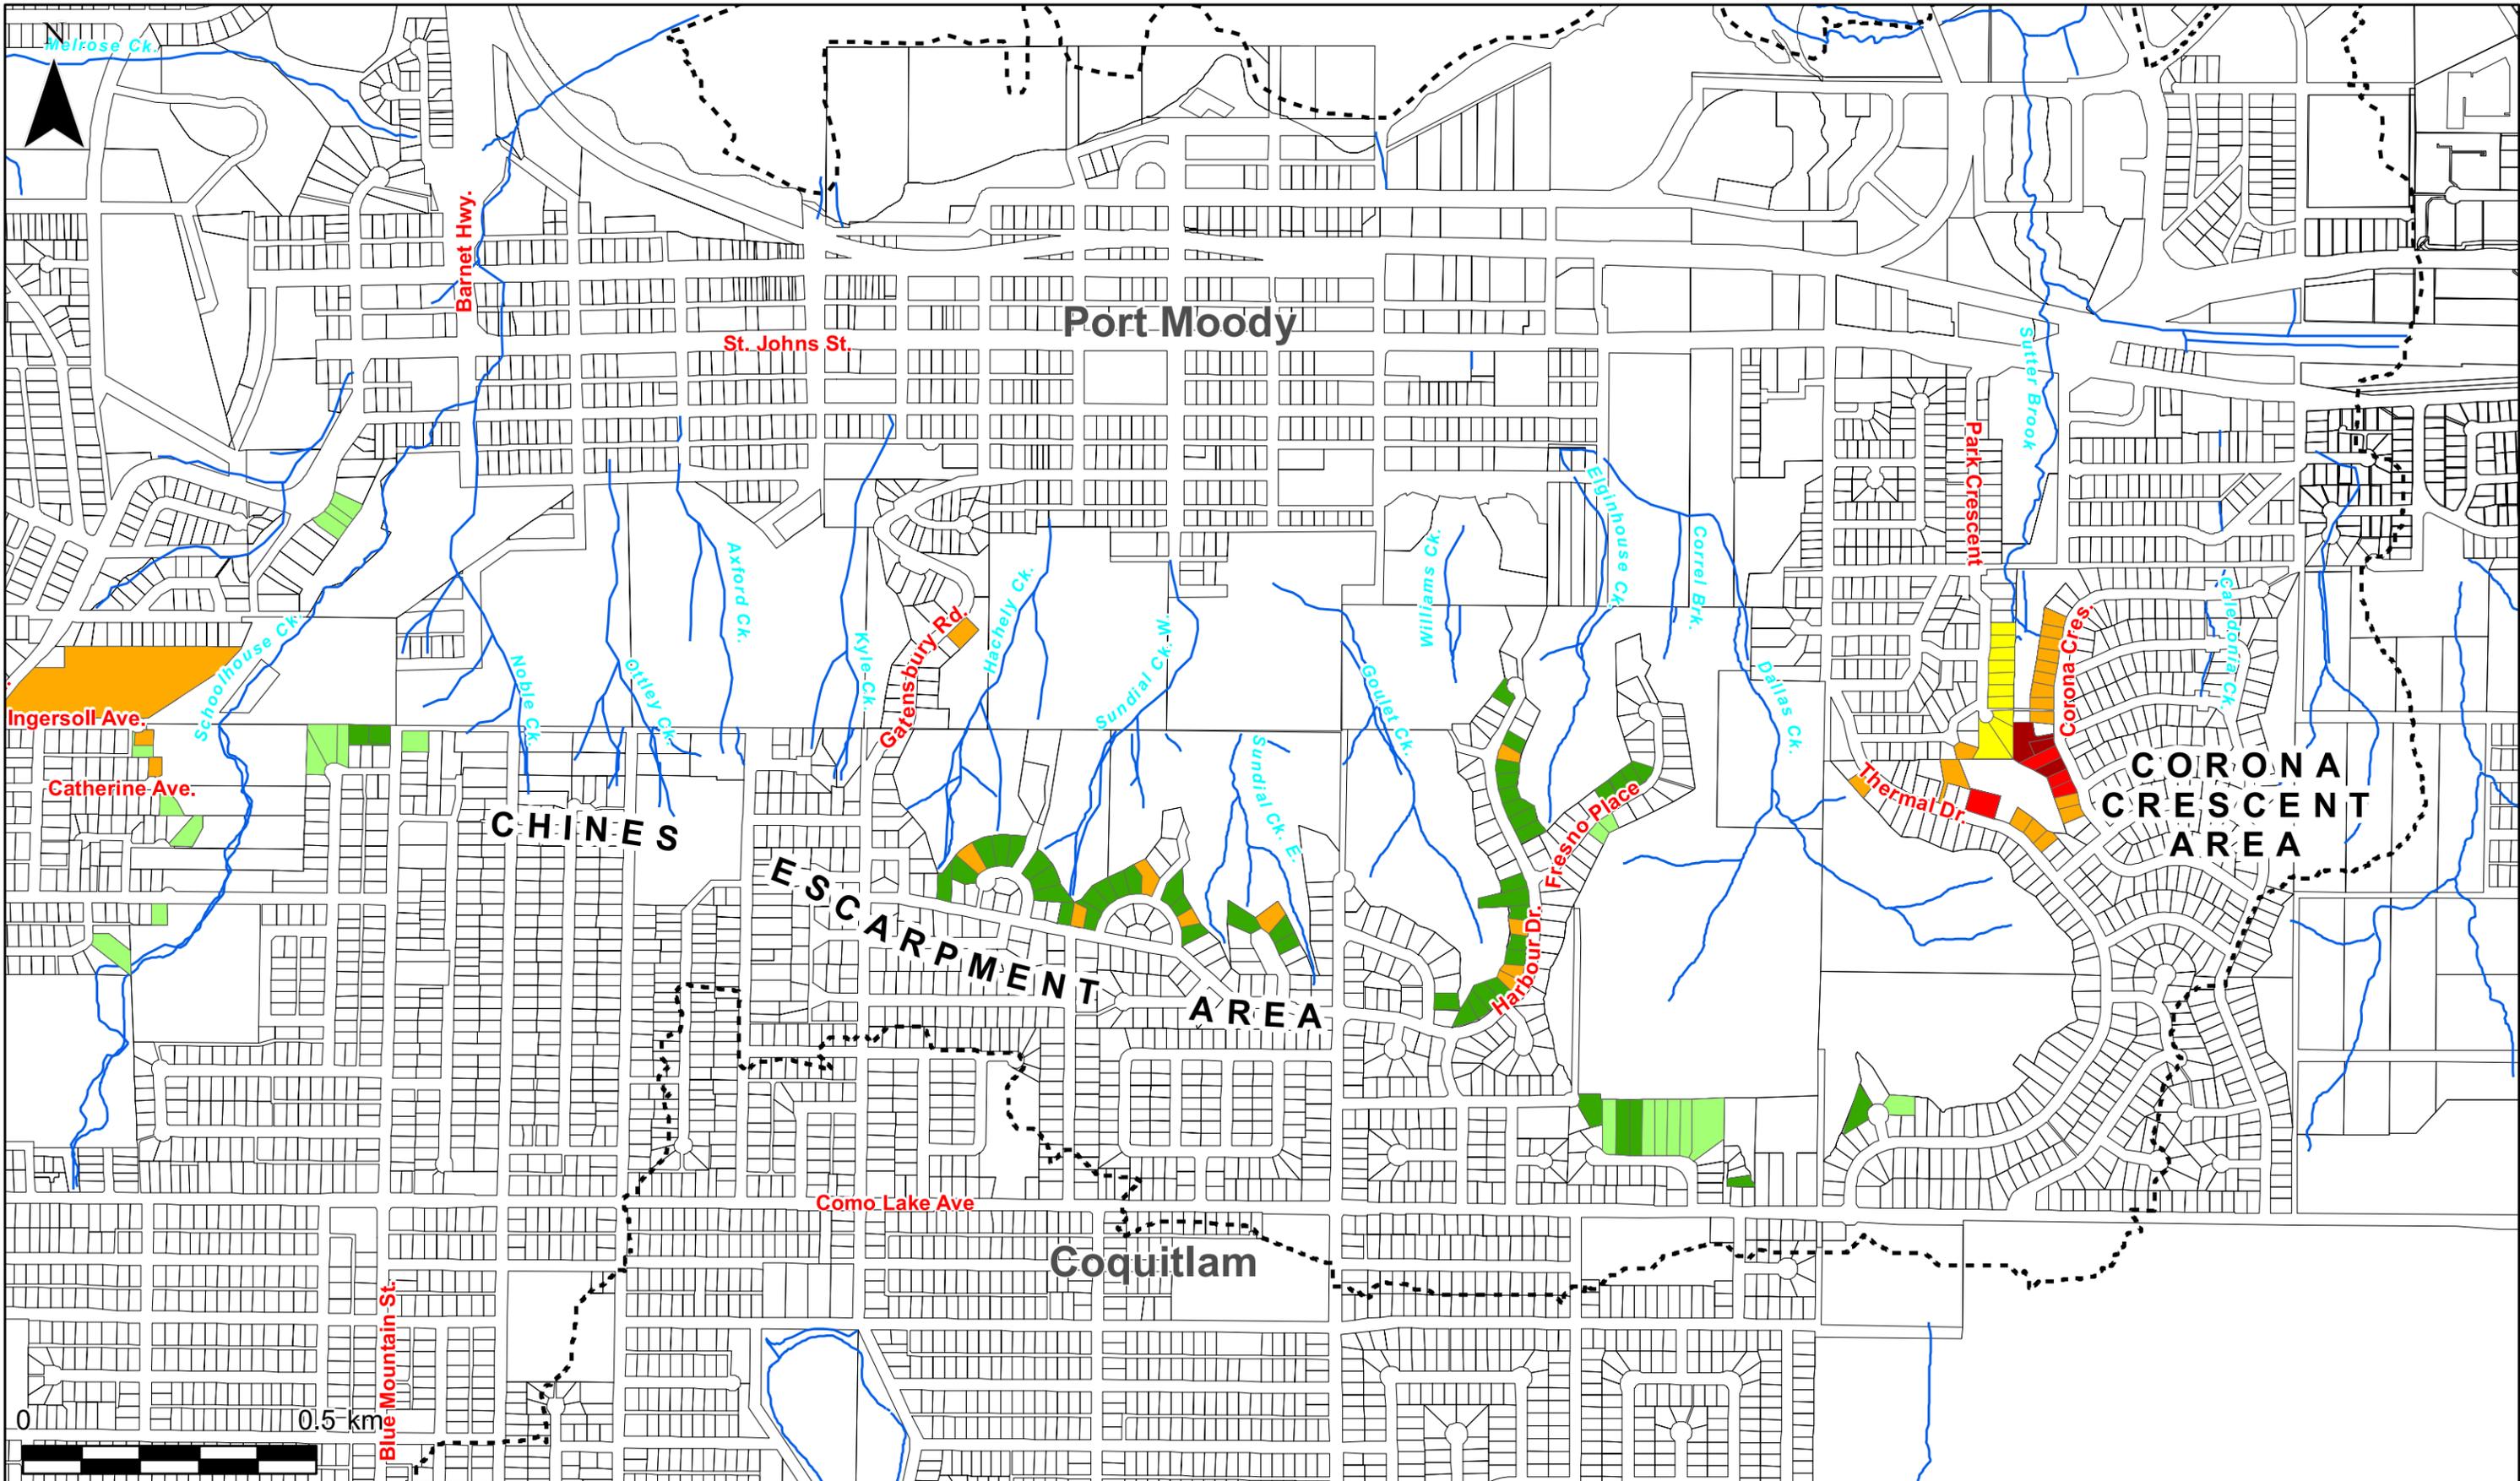
PORT MOODY COQUITLAM DRAINAGE AREA ISMP
Figure 1-1: Project Area and Landslide and Erosion Events

The Phase I report (Table 3-15 therein) provided an inventory of recorded landslide events based on Thurber (1983, 1988), Eisbacher and Clague (1981) and Golder (2007). The locations of these previously reported slides are indicated on Figure 1-1. This information has been compiled with additional information regarding new landslides, landslide triggers and the spatial aspects of deposition zones in Table 3-2.

In December 1979 at the head of Ottley Creek ravine, a large fill deposit (estimated at about 4,000 m³) on a steep slope failed due to erosion from high stormwater flow after several days of heavy rainfall (Eisbacher and Clague (1981); Thurber (1988); Evans and Savigny (1994)) (Figure 1-1). The fill consisted of mineral soil from construction excavations and wood debris from land clearing. The failure resulted in a large debris slide into the creek, which temporarily blocked the creek. This debris slide then developed into a channelized debris flow, which moved rapidly down Ottley Creek ravine, incorporated additional soil, wood debris and water, exited the ravine and spread over the residential area below as an unconfined debris flow. Mixed soil, wood debris and sorted gravels were deposited at the ravine mouth and sediment trails were deposited along the water tracks. There is anecdotal evidence that the debris flow traveled in pulses.

The debris flow damaged several residences, structures and vehicles, and put lives in danger (Figure 1-1; Eisbacher and Clague (1981); Thurber (1988)). This debris flow nearly caused serious injury to four people - a house with three residents was impacted by the debris and knocked off its foundation, and a basement apartment with one resident was rapidly inundated. The people managed to escape the affected houses, and no serious injuries occurred (Eisbacher and Clague (1981); Thurber (1988); Evans and Savigny (1994)).
